PRELIMINARY REPORT
of the
FERGUSON INCIDENT

Gabriel G. Alexander P.E.

FERGUSON INCIDENT REPORT

ENGINEER'S REPORT

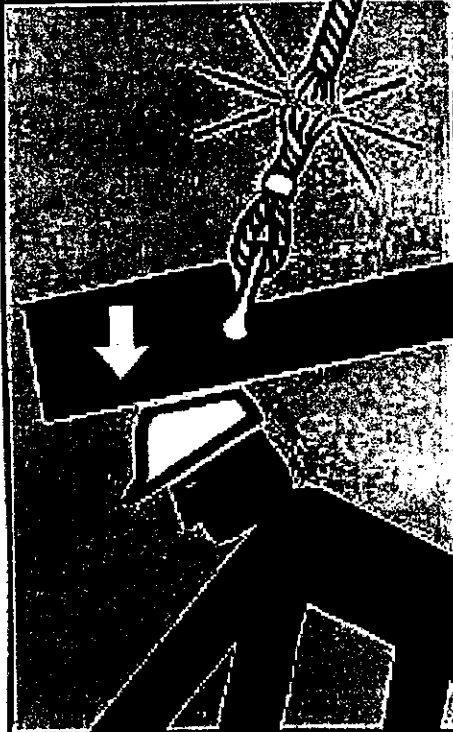
Figure 1

Wire rope **WILL FAIL** if worn-out, overloaded, misused, damaged, improperly maintained or abused.
Wire rope failure may cause serious injury or death!

The Associated Wire Rope Fabricators is the association that sponsors the Wire Rope Users Manual, and the Wire Rope Technical Board. The Association supplies the following warning, which appears in color in figure 1 ⁽¹¹⁾:

The warning is dated 1993, by the Wire Rope Fabricators.
